Manhole Inspection Summary

Manhole # S69Y__014MH

Insp Date: **5/30/08 1:16 PM**

Location Address: **6301 Van Deman St.**

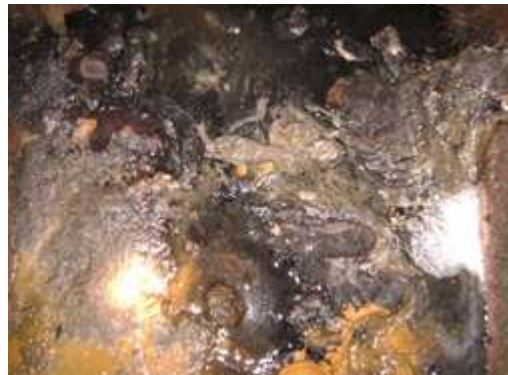
Defect 1

☒ **Evidence Of Surcharge** Depth: **1** (ft.) ☐ Active Surcharge Present

surcharge

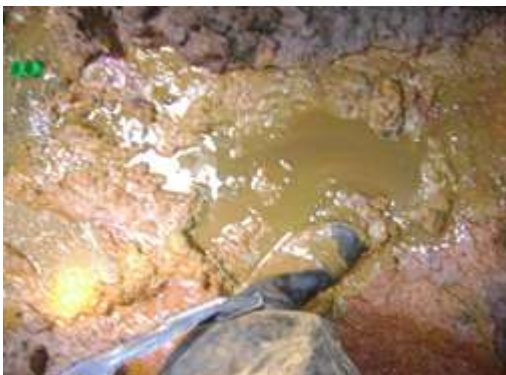
Defect 2

Comments **1 O'CLOCK AND 11 O'CLOCK CLOSED WITH BRICKS BUT THEIR DROP EXTENSIONS ARE OPEN. DEBRIS IS STANDING IN CHANNEL, NOT MOVING**

Condition: ☐ Sound ☐ Cracked ☐ Root Intrusion ☐ Deteriorated ☐ Leaks ☒ **Debris**

debris in channel

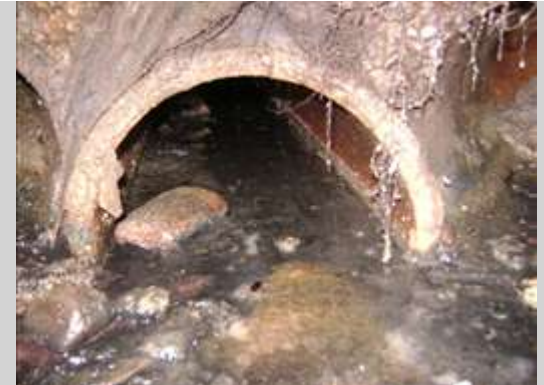
12 O'Clock Outflow

Pipe Height: **15.6** (in.) Rod Only (Angled)
Pipe Material: **Clay** ☐ Pipe Lined
Invert Depth: **7.50** (ft.) Flow Characteristics: **Slow**
Deposits: ☐ None ☒ **Mud** ☒ **Sludge** ☒ **Debris** ☐ Grease
Silt Depth: **4** (in.) Deposits Extent: **Medium**
Infiltration: **None** Pipe Seal Cond: **Sound**

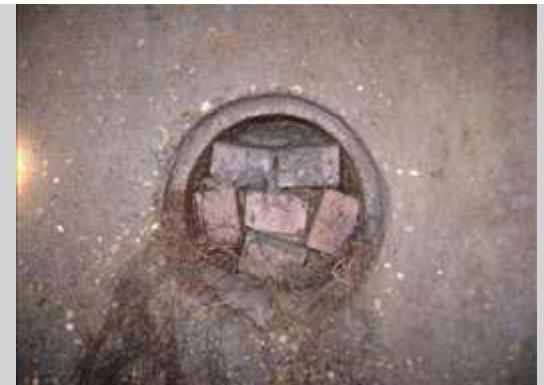
1 O'Clock Inflow

Pipe Height: **8.4** (in.) Rod Only
Pipe Material: **Clay** ☐ Pipe Lined
Invert Depth: **4.33** (ft.) Flow Characteristics: **None**
Deposits: ☐ None ☒ **Mud** ☒ **Sludge** ☒ **Debris** ☐ Grease
Silt Depth: **1** (in.) Deposits Extent: **Light**
Infiltration: **None** Pipe Seal Cond: **Sound**

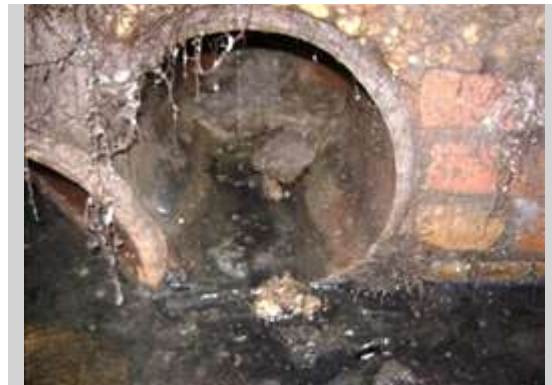
Drop In @ 1 O'Clock

Drop: **Outside** Rod Only
Angled: Reading: **7.42** (ft.)
Inv Depth: **7.42** (ft.)

Drop Condition: **Open**

Connects To: **Stub connection / abandoned**

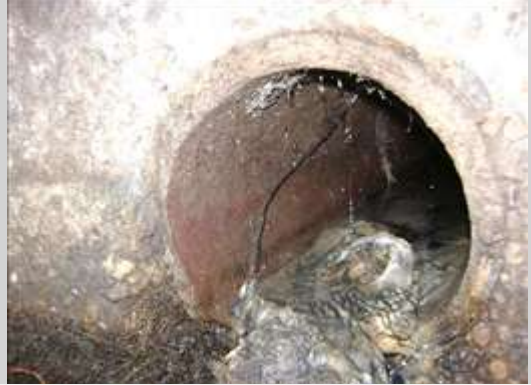
4 O'Clock Inflow

Deposits: ☐ None ☒ **Mud** ☒ **Sludge** ☒ **Debris** ☐ Grease

Silt Depth: **1** (in.) Deposits Extent: **Light**

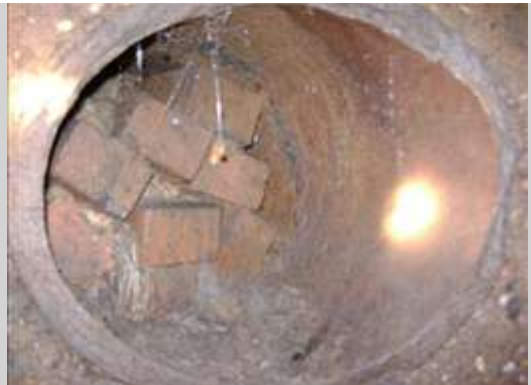
11 O'Clock Inflow

Deposits: ☐ None ☒ **Mud** ☒ **Sludge** ☒ **Debris** ☐ Grease

Silt Depth: **1** (in.) Deposits Extent: **Light**

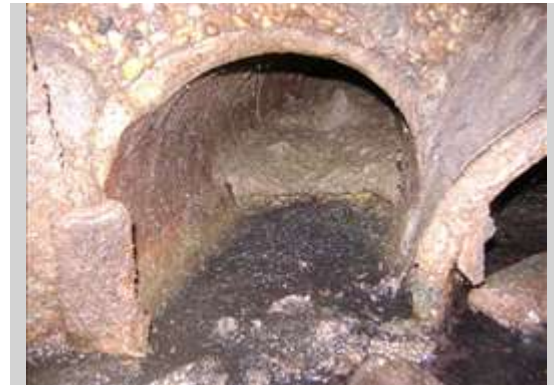
Drop In @ 11 O'Clock

Drop: **Outside** Rod Only

Drop Condition: **Open**

Connects To: **House connection / Service line**
